Thornapple River Watershed Management Plan

Approved June 2016

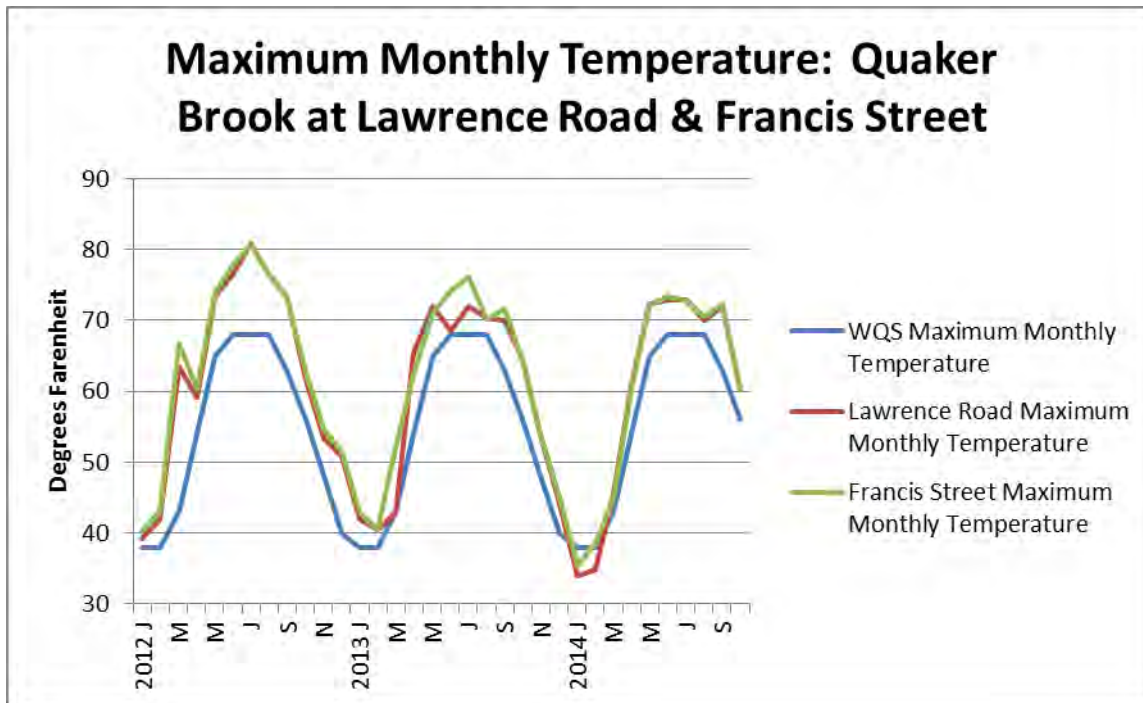
The Barry Conservation District utilized HOBO temperature loggers to monitor temperature on three cold water tributaries in the Thornapple River watershed from January 2012 through October 2014. Two loggers were placed on Quaker Brook – one at Lawrence Road and one at Francis Road. These locations were chosen to be upstream and downstream of streambank restoration projects on Quaker Brook. Maximum monthly temperature data from Quaker Brook are charted below, with tables expressed in Appendix 4. Monthly temperatures for Quaker Brook at both locations regularly exceed Michigan’s water quality standards for cold water streams. Quaker Brook exceedences reach a maximum of 12 degrees Fahrenheit (July 2012).
